**SUPPLEMENT TO WATER COMPLIANCE INSPECTION REPORT FORM  
(EPA FORM 3560-3 (REV 9-94))**

**DNER DE DIEGO PUMP STATION, DE DIEGO STREET MSJ, PRASA,  
AND DTPW COLLECTION SYSTEMS**

Inspection Date: July 11, 2013

**DNER De Diego PS Drainage Area RI**

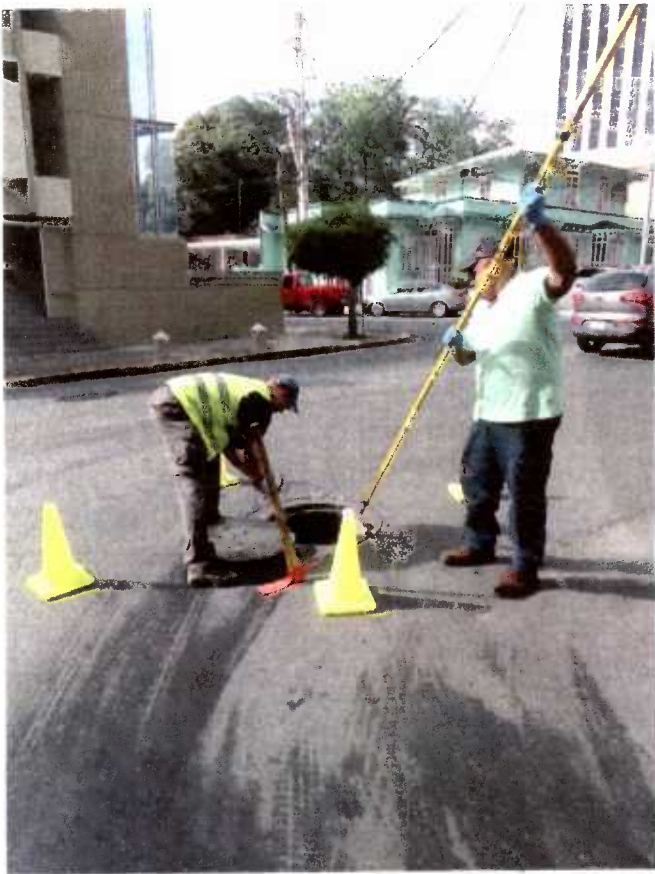
**Storm water manhole #1**

- b. Circular pipe #1 flow comes from the Baldorioty de Castro Avenue North Marginal Street and De Diego Ave. intersection. See Attachment I – Location Map for more details. A grab sample was taken from circular pipe No. 1 within SW MH #1 and field testing, using ammonia test strips indicated that the ammonia level was between 1 to 3 mg/l. Additionally, using the surfactants sampling kit the result for surfactants was approximately 1.5 ppm (mg/l). There were no foul odors. See Attachment 2 Photo No. 2.

Note: A grab sample was taken at circular pipe #1 and using ammonia test strips the ammonia level was between 1 to 3 mg/l. Additionally, using a surfactant sampling kit the results for surfactants was approximately 1.5 ppm.

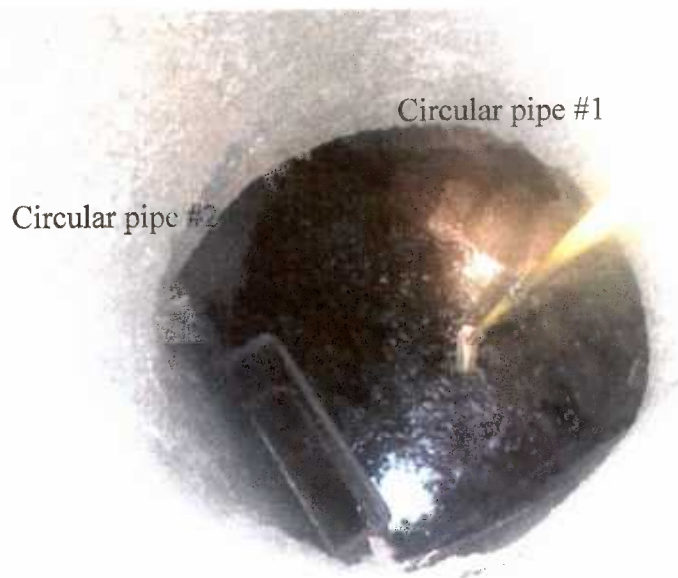
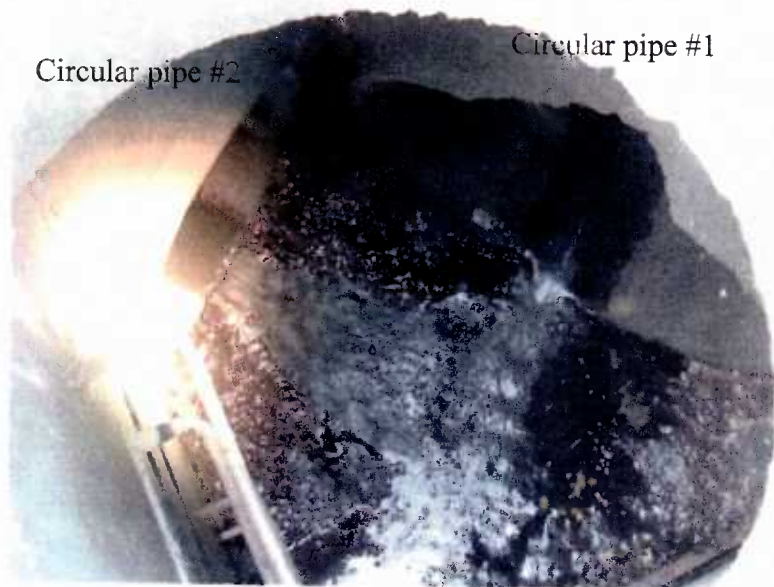
- a. Storm water manhole #1 (SW MH #1): Is located at the southwest corner of De Diego Ave. and Estrella Street intersection and at the corner in front of Diana's Pizza. See Attachment I – Location Map for more details. EPA opened the manhole and observed two large circular pipes, circular pipe #1 and circular pipe #2. Both pipes with significant amount of dry-weather flow. See Attachment 2 Photos No. 1 thru No. 5 and Photo No. 10.

Note: EPA opened the manhole and observed two large circular pipes, circular pipe #1 and circular pipe #2. Both pipes with significant amount of dry-weather flow.

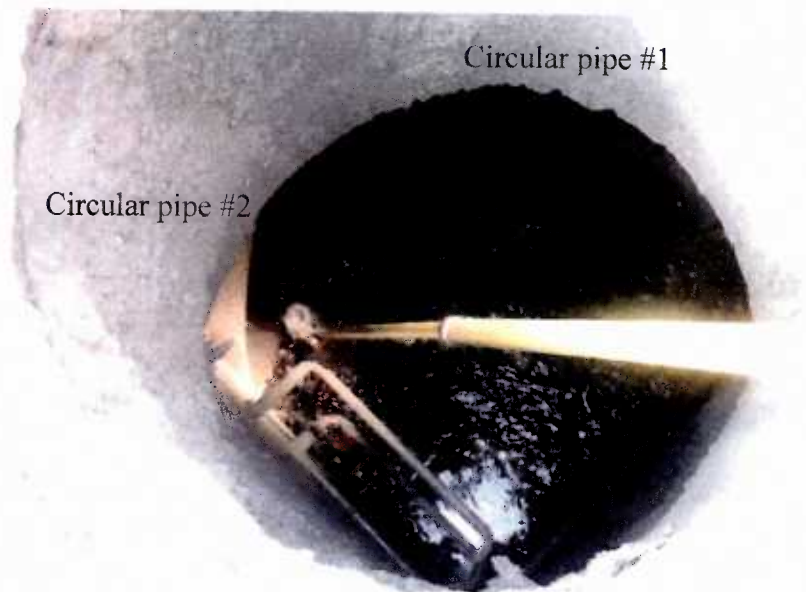
Storm water manhole #1

- c. Circular pipe #2 enters stormwater manhole No. 1 from the east. The flow comes from a parallel storm water collection manhole at the De Diego Ave. that appears to collect the flow from the Martín Travieso Street. See Attachment I – Location Map for more details. A grab sample was taken and using ammonia test strips the ammonia level was between 0 to 0.25 mg/l. Additionally, using a surfactant sampling kit the results for surfactants was approximately 1.5 ppm. There were no foul odors. See Attachment 2 Photo No. 4.

Note: A grab sample was taken at circular pipe #2 and using ammonia test strips the ammonia level was between 0 to 0.25 mg/l. Additionally, using a surfactant sampling kit the results for surfactants was approximately 1.5 ppm.

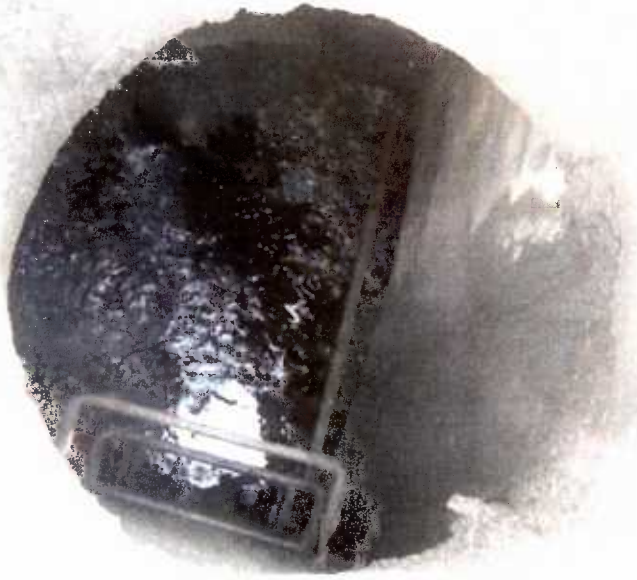
Note: A piece of wood was found obstructing the flow that afterward flows into the DNER De Diego PS.

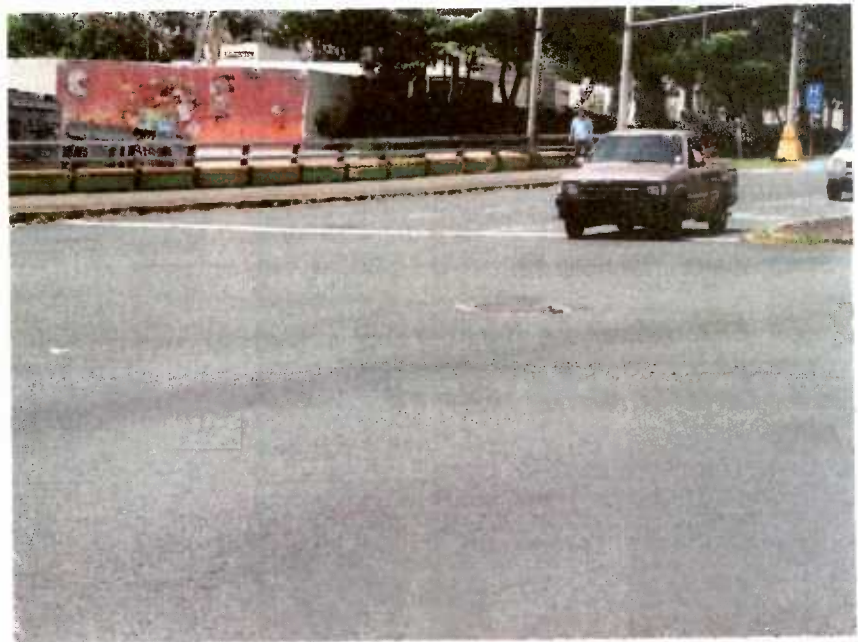
**Storm water manhole #2**

- e. Storm water #2 (SW MH #2): Located at the Baldorioty de Castro Avenue north marginal and De Diego Ave. intersection. See Attachment I – Location Map for more details. EPA opened the manhole and observed dry-weather flow, north, in the direction of the De Diego Street DNER PS Area. The manhole appeared to be approximately forty feet deep. See Attachment 2 Photos No. 6 thru No. 9.

Note: Storm water #2: Located at the Baldorioty de Castro Avenue north marginal and De Diego Avenue intersection.

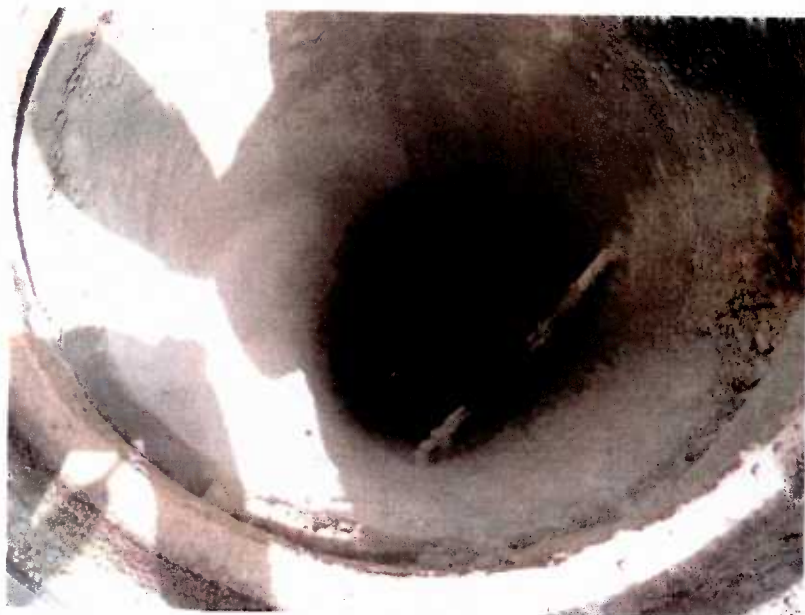
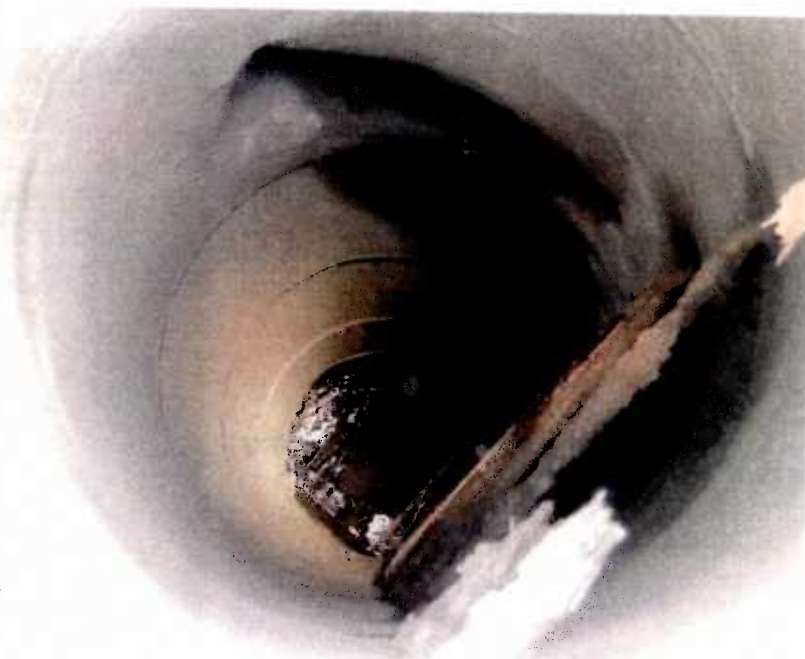
Storm water manhole #2

Note: EPA opened the manhole and observed dry-weather flow in direction to the De Diego Avenue DNER PS Area.

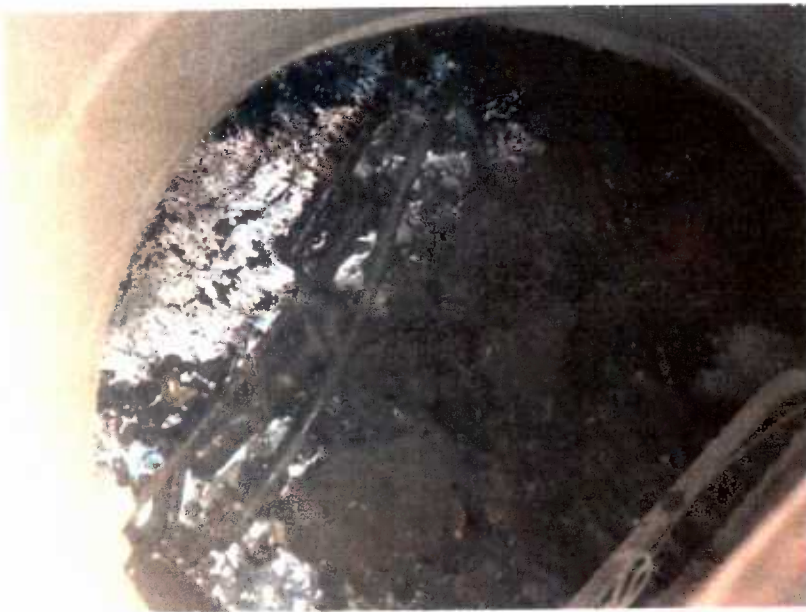
Note: EPA opened the manhole and observed dry-weather flow in direction to the De Diego Avenue DNER PS Area.

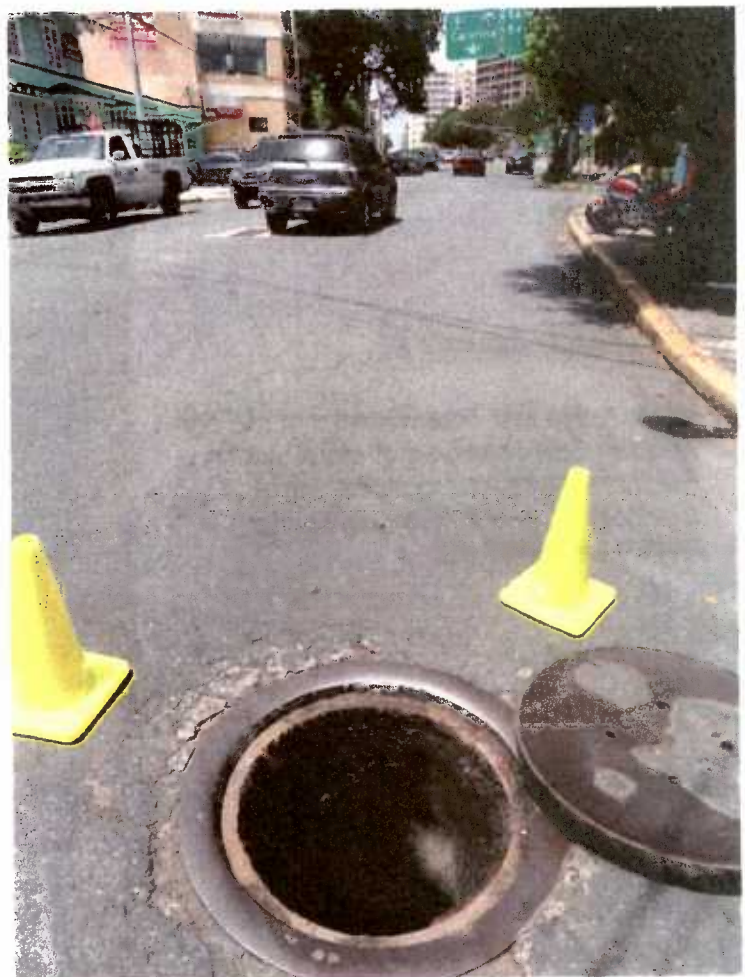
Storm water manhole #1

Note: View from storm water manhole #1 in direction of storm water manhole #2.

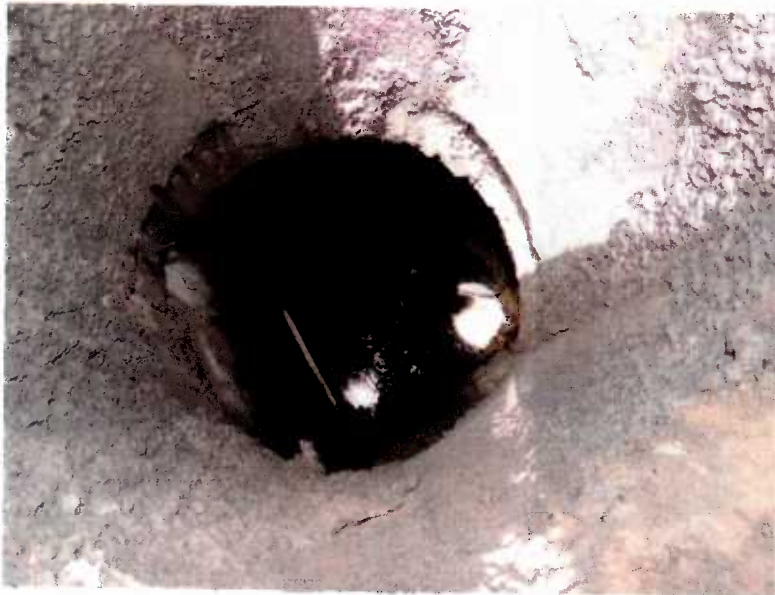
- f. A dye test was conducted to determine the source of circular pipe #1 flow. Green dye was applied at SW MH #2. The dye test determined that the dry-weather flow observed at storm water manhole #2 flows into storm water manhole #1 and subsequently into DNER De Diego PS. See Attachment 2 Photos No. 10 thru No. 12.

Note: A dye test determined that the dry-weather flow observed at storm water manhole #2 flows into storm water manhole #1 and subsequently into DNER De Diego PS.

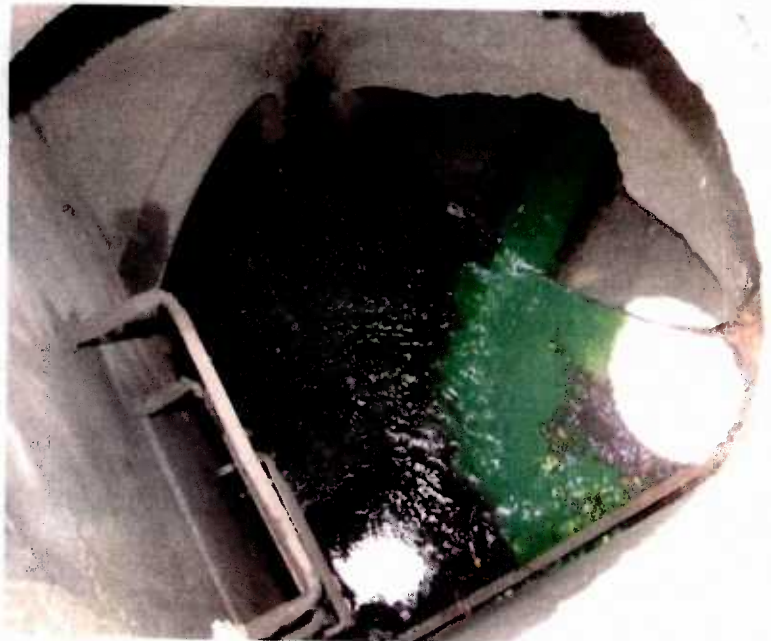
Storm water manhole #1

Note: A dye test determined that the dry-weather flow observed at storm water manhole #2 flows into storm water manhole #1 and subsequently into DNER De Diego PS.

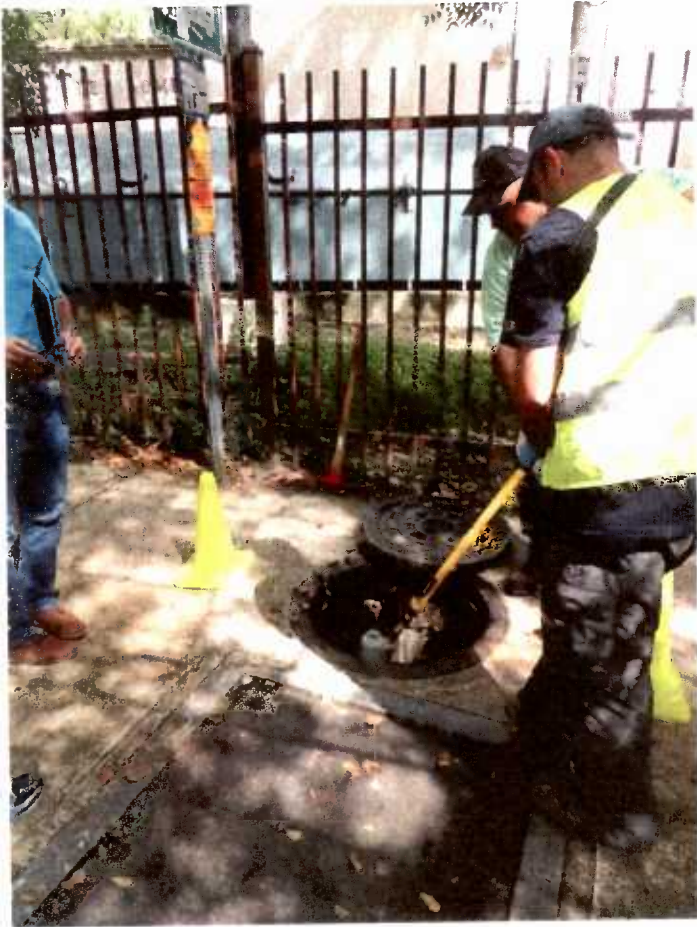
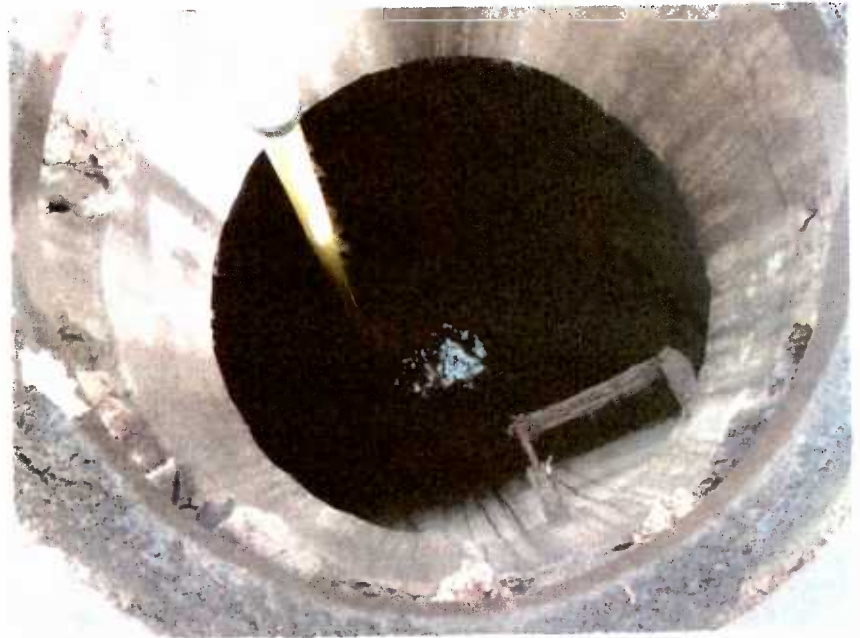
**Storm water manhole #3**

a. Storm water manhole #3: Located at the De Diego Ave. sidewalk, adjacent to the public bus stop and the DNER De Diego PS property fence (diesel tank). See Attachment I – Location Map for more details. EPA opened the manhole and noted dry weather flow and foul odors. A grab sample was taken using ammonia test strips the ammonia level was 0.25 mg/l. Additionally, using a surfactant sampling kit the results for surfactants was between 0.25 and 0.50 ppm. See Attachment 2 Photo No. 4. See Attachment 2 Photos No. 13 and No. 14.

**Note:** EPA opened the manhole and dry weather flow and foul odors were noted. A grab sample was taken and using ammonia test strips the ammonia level was 0.25 mg/l. Additionally, using a surfactant sampling kit the results for surfactants was between 0.25 and 0.50 ppm.

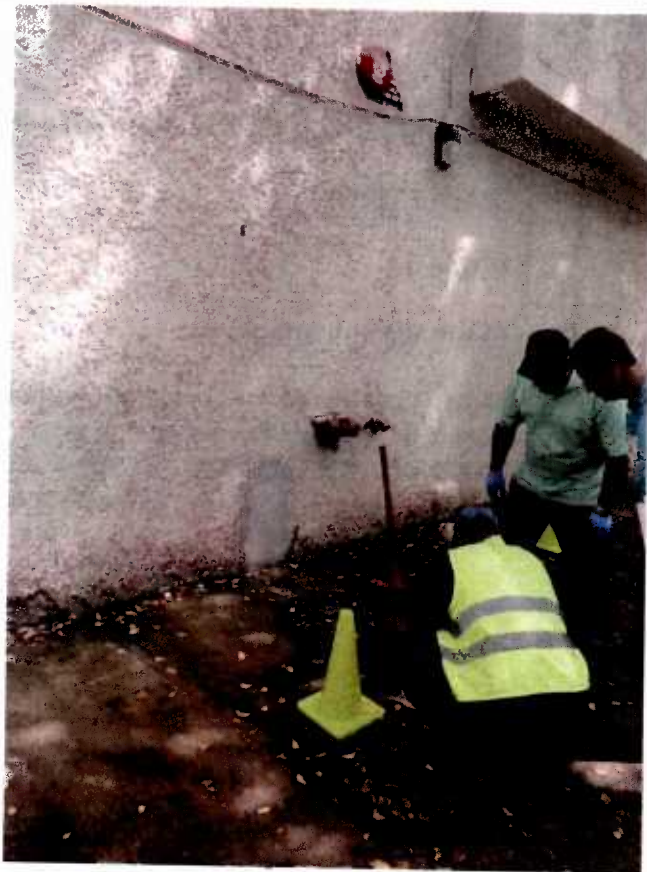
Note: Located at the De Diego Avenue Sidewalk to the right of Supermax supermarket. Grab samples were taken at this location. EPA opened the manhole and dry weather flow and foul odors were noted.

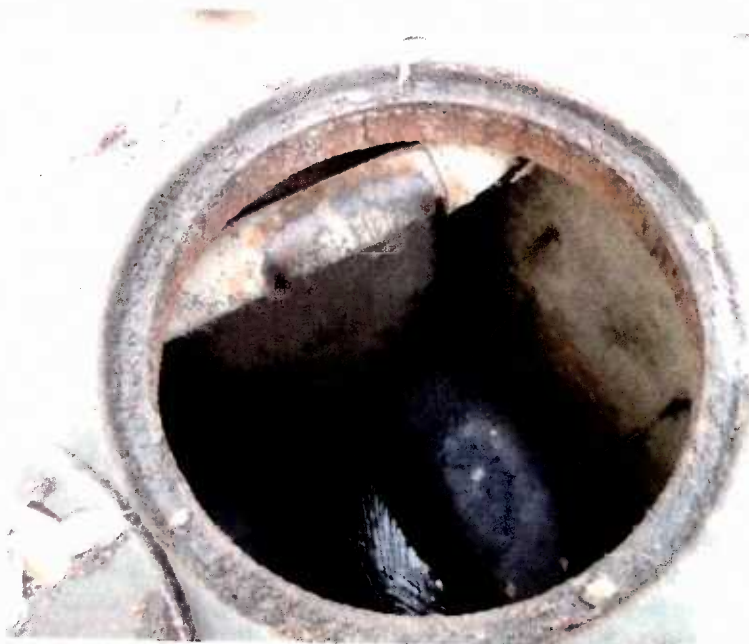
Storm water manhole #4

Additionally, a PVC pipe was found crossing the upper part of the manhole and connected into the storm drain at De Diego Street. Dry-weather flow was observed at the street curb and into the storm water drain inlet. The pipe appears to be flowing from the Supermax supermarket building. See Attachment 2 Photos No. 16 and No. 19 thru No. 22.

Note: A PVC pipe was found crossing the upper part of the manhole and connected into the storm drain at De Diego Avenue.

This area is considered a potential area of non-compliance that needs further investigation and collaboration between MSJ and the DTPW and PRASA to control and mitigate the illicit discharges of pollutants into the DNER De Diego PS and subsequently into the Condado Beach Area and the Atlantic Ocean.

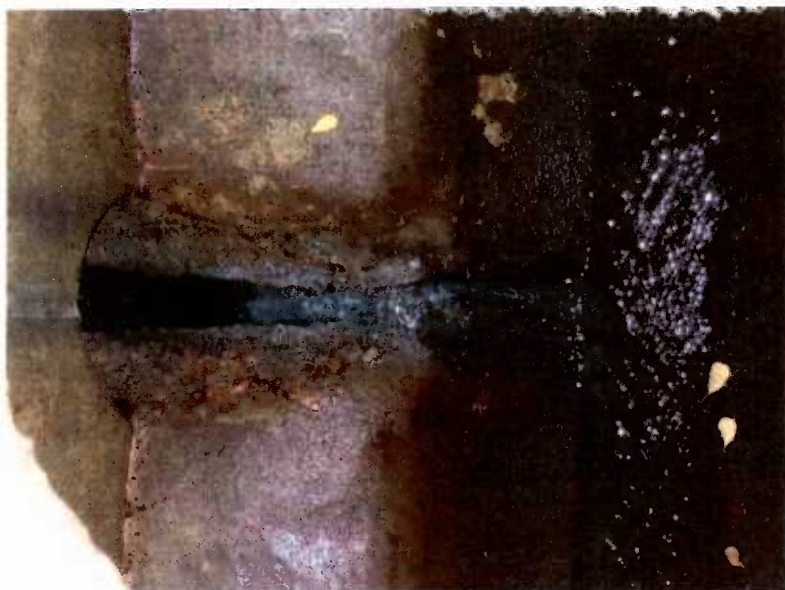
b. Storm water manhole #4: Located at the De Diego Ave. (West) sidewalk adjacent to the eastern wall (along De Diego Avenue) of the Supermax supermarket. See Attachment I – Location Map for more details. EPA opened the manhole and noted dry weather flow and foul odors. Wastewater was observed flowing east from under Supermax and entering the storm sewer (on the west side of the manhole) from an approximately 16 inch pipe at the bottom at the manhole. A grab sample was taken and using ammonia test strips the ammonia level was between 3 and 6 mg/l. This discharge had a strong sewage odor and there was algal growth in the 16" pipe. See Attachment 2 Photos No. 15 thru No. 18.

Note: Wastewater was observed flowing from an approximately 16 inch pipe at the bottom at the manhole. A grab sample was taken and using ammonia test strips the ammonia level was between 6 and 3 mg/l.

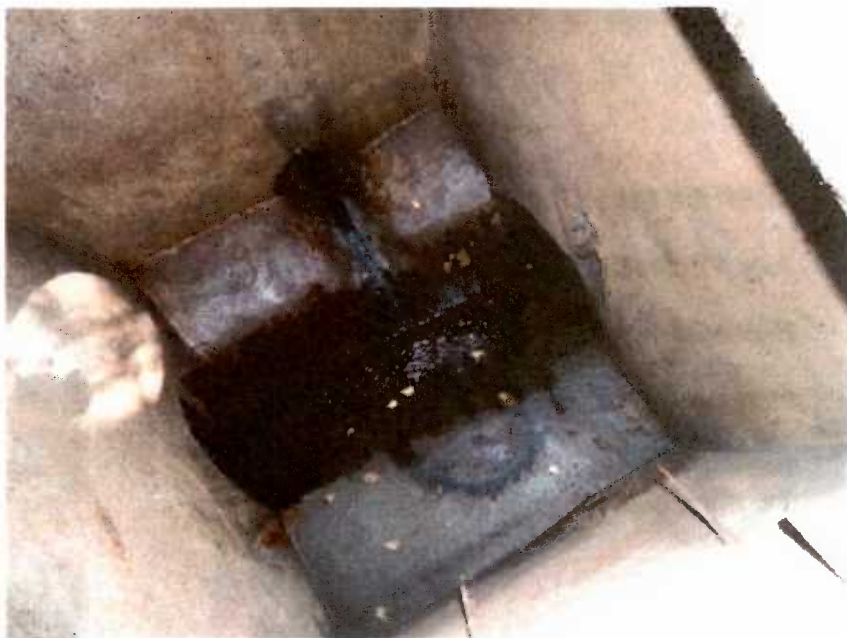
**Storm water manhole #4**

Note: Wastewater was observed flowing from an approximately 16 inch pipe at the bottom at the manhole. A grab sample was taken and using ammonia test strips the ammonia level was between 6 and 3 mg/l.

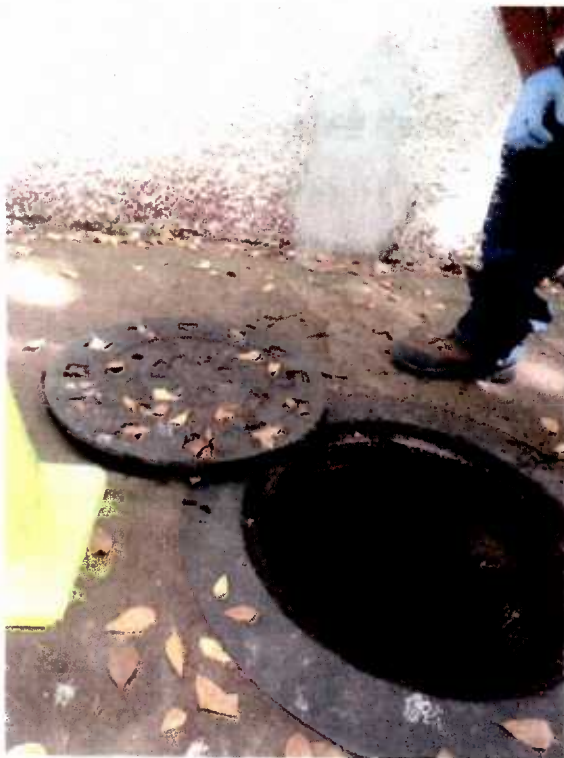
Note: A PVC pipe was found crossing the upper part of the manhole and connected into the storm drain at De Diego Avenue. A grab sample was taken and using ammonia test strips the ammonia level was between 6 and 3 mg/l.

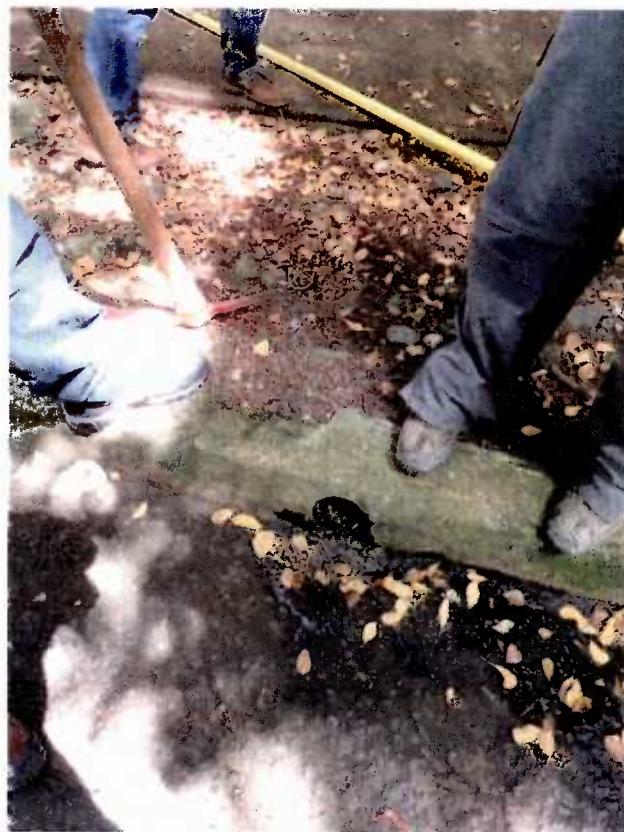
**Storm water manhole #4**

Note: Dry-weather flow was observed at the street curb and into the storm water drain inlet.

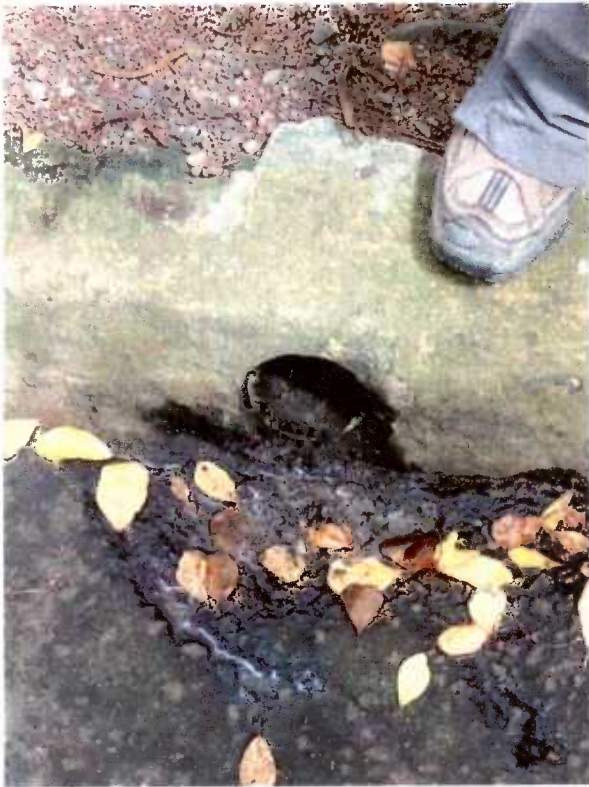
Note: Dry-weather flow was observed at the street curb and into the storm water drain inlet.

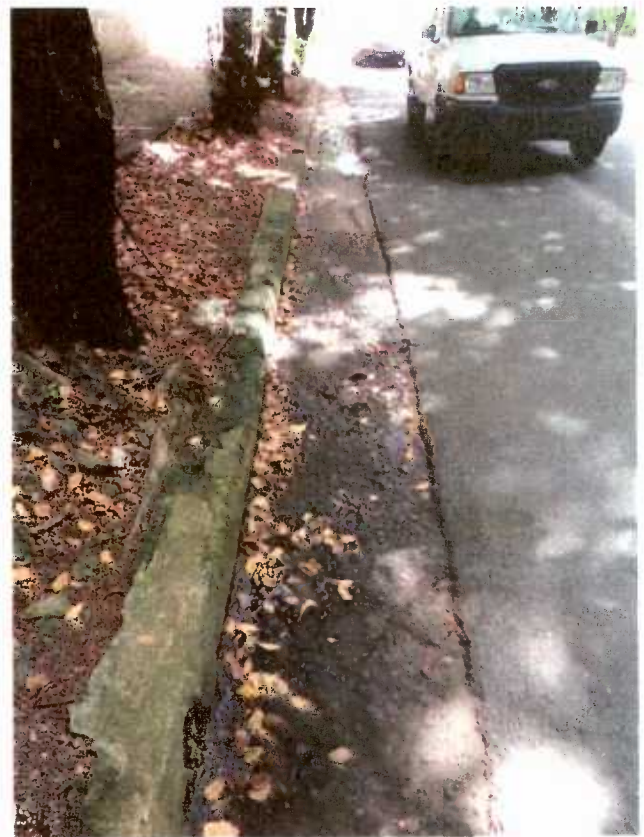
**Storm water manhole #4**

Note: Dry-weather flow was observed at the street curb and into the storm water drain inlet.

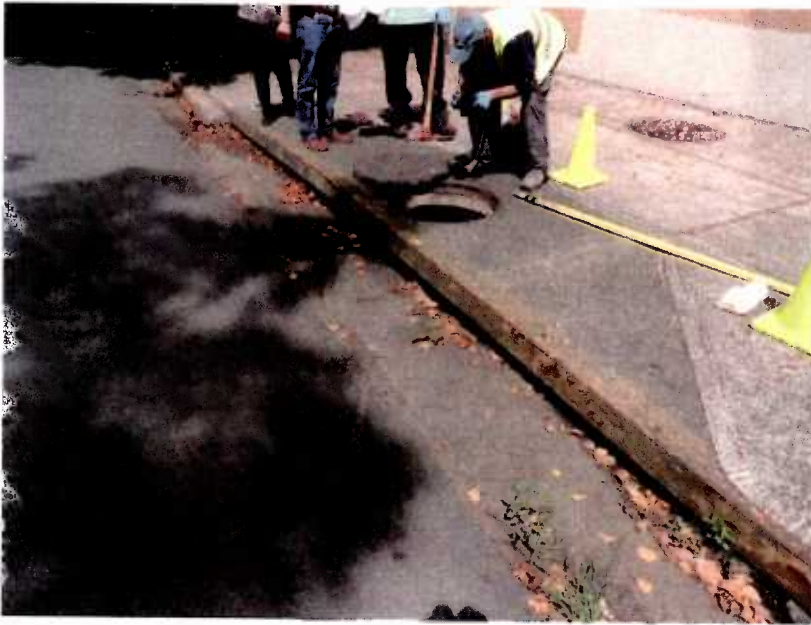
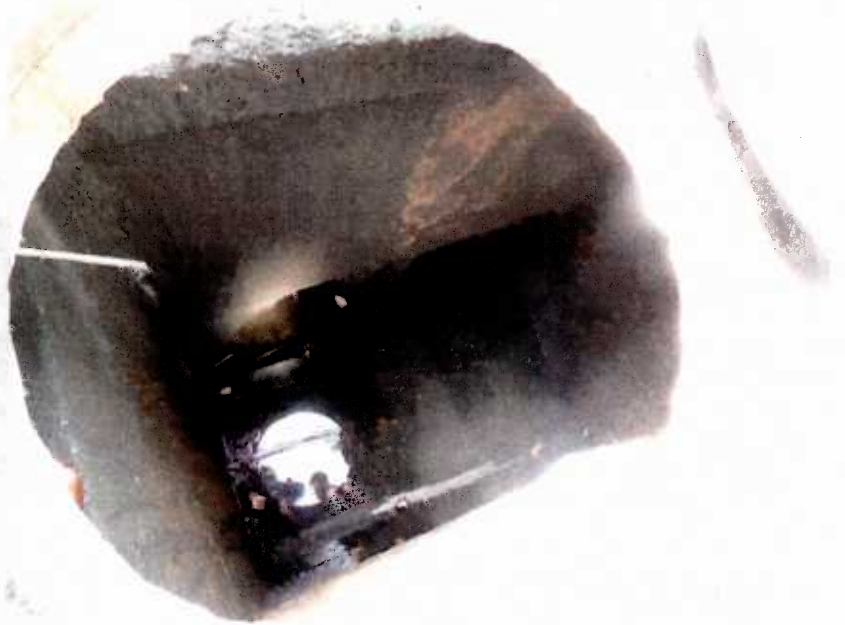
c. Storm water manhole #5 and #6: Located at the De Diego Ave. sidewalk to the right of Supermax supermarket. See Attachment I – Location Map for more details. EPA opened the manholes and some dry weather flow was observed. No foul odors were noted. Both manholes are connected to the De Diego Street storm water inlet. De Diego Street storm water inlets are an appurtenance of DTPW. A grab sample was taken and using ammonia test strips the ammonia level was 0.5 mg/l. See Attachment 2 Photos No. 23 thru No. 27.

Note: Some dry weather flow was observed. No foul odors were noted. Manhole connected to the De Diego Avenue storm water inlet.

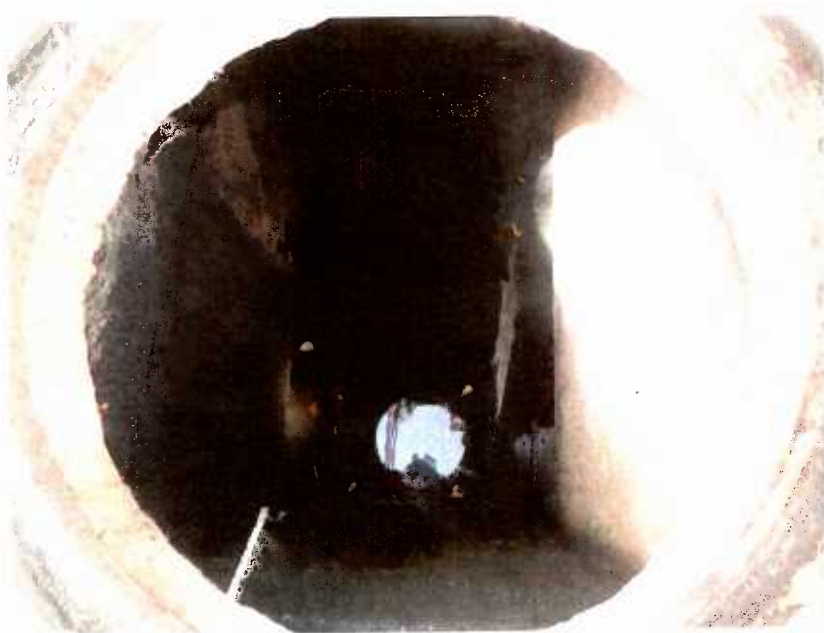
Note: Some dry weather flow was observed. No foul odors were noted. Manhole connected to the De Diego Avenue storm water inlet. A grab sample was taken and using ammonia test strips the ammonia level was 0.5 mg/l.

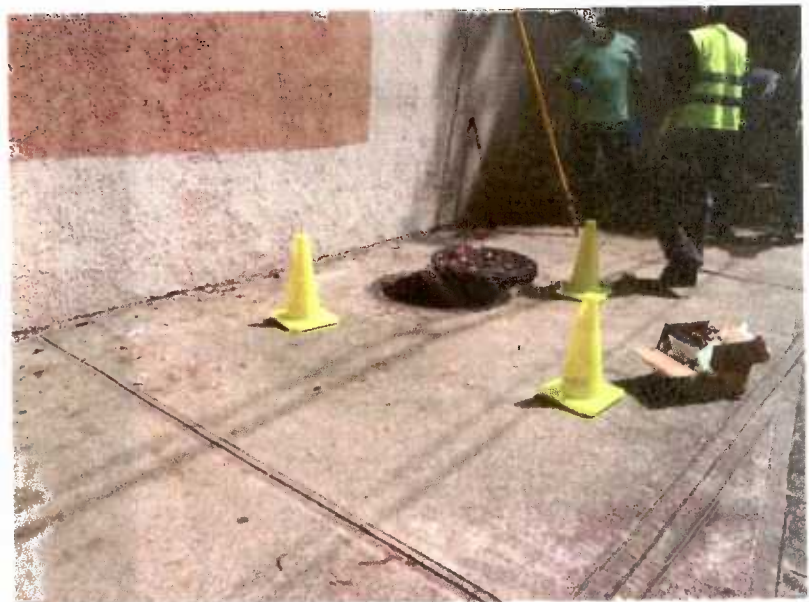
Storm water manhole #6

Note: Manhole is connected to the storm water inlet at De Diego Avenue and showed at Photo No. 23.

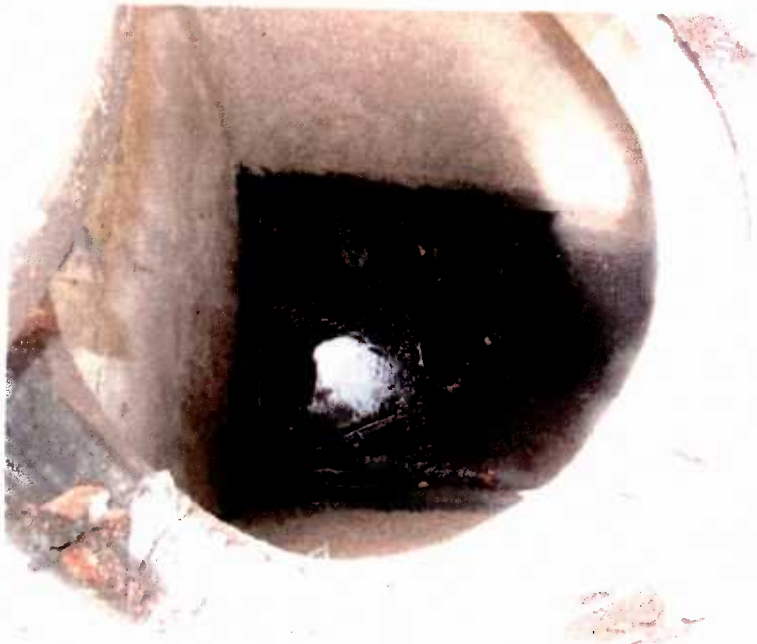
Note: Water accumulation and storm water solids were observed.

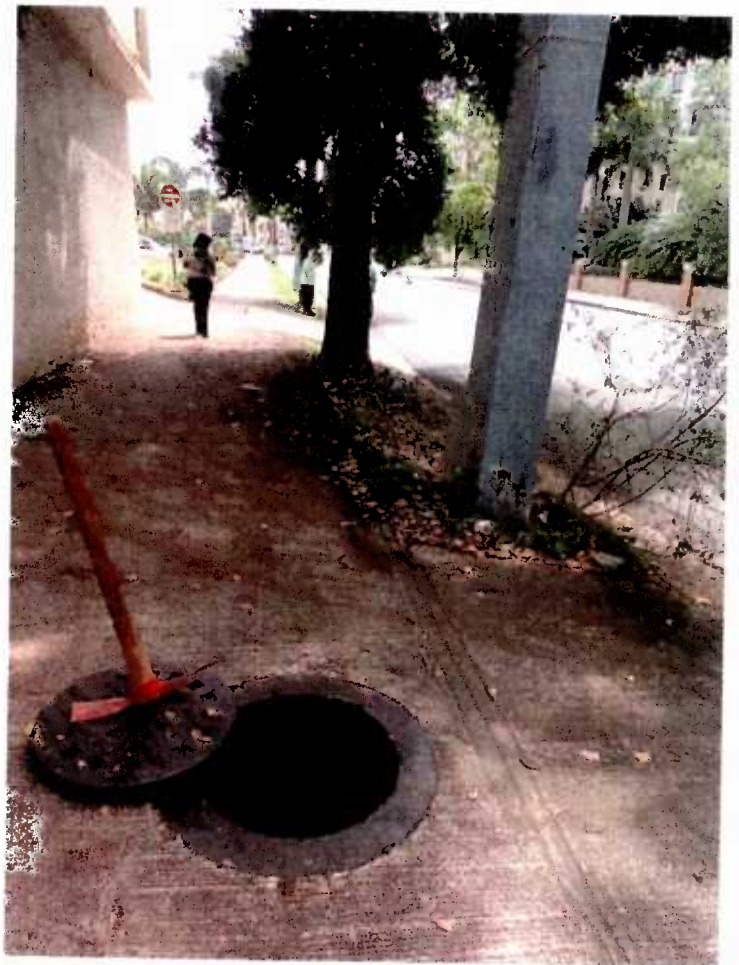
Storm water manhole #7

d. Storm water manhole #7: Located at the De Diego Ave. sidewalk to the right of Supermax supermarket. See Attachment I – Location Map for more details. EPA opened the manhole and was found with significant amounts of grease accumulation. The flow channel at the bottom of the manhole was obstructed. See Attachment 2 Photos No. 28 thru No. 31.

Note: Located at the De Diego Avenue Sidewalk to the right of Supermax supermarket.

This area is considered a potential area of non-compliance that needs further investigation and collaboration between MSJ and the DTPW and PRASA to control and mitigate the unlawful discharges of pollutants into the DNER De Diego PS and subsequently into the Condado Beach Area and the Atlantic Ocean.

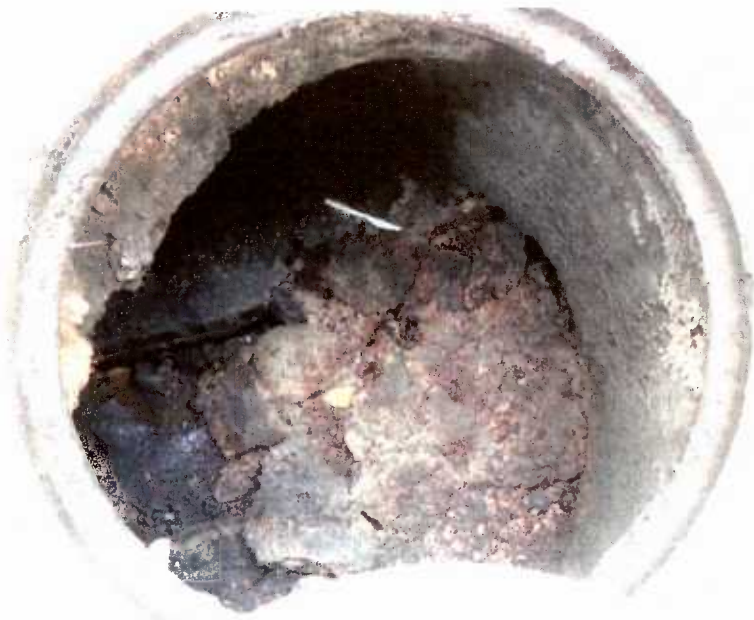
Note: EPA opened the manhole and was found with significant amounts of grease accumulation. The flow channel at the bottom of the manhole was obstructed.

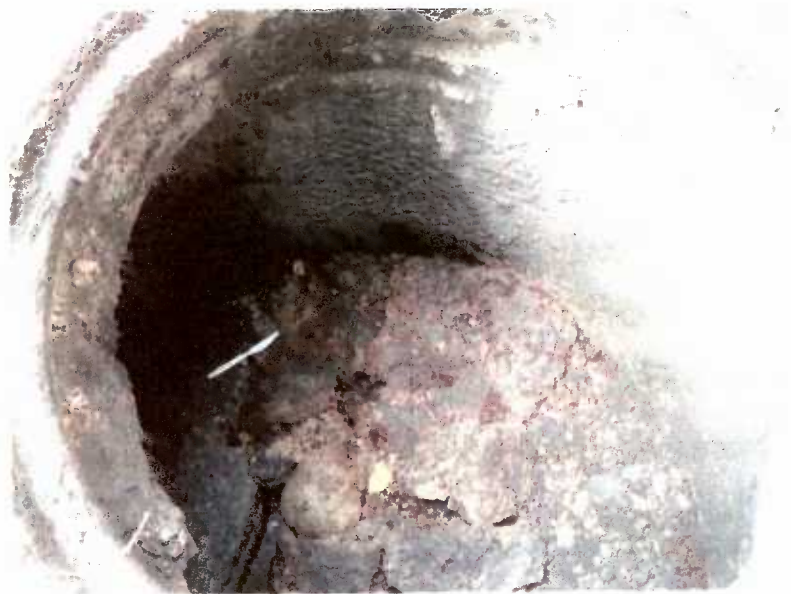
**Storm water manhole #7**

Note: EPA opened the manhole and was found with significant amounts of grease accumulation. The flow channel at the bottom of the manhole was obstructed.

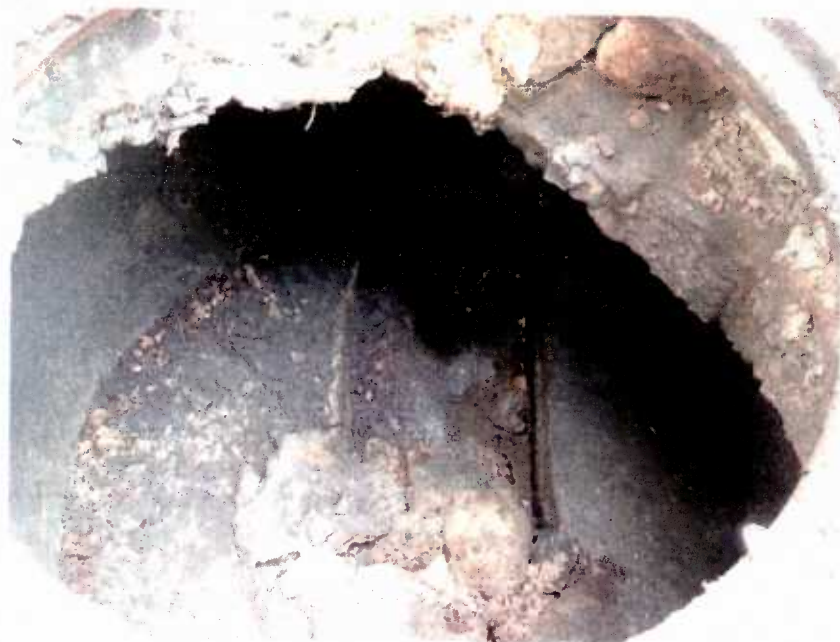
Note: EPA opened the manhole and was found with significant amounts of grease accumulation. The flow channel at the bottom of the manhole was obstructed.

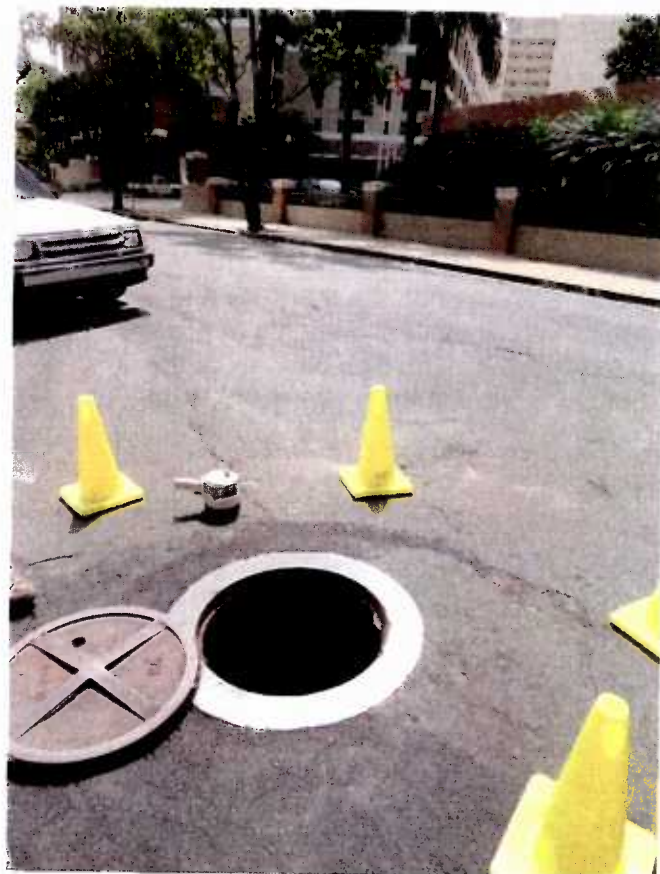
PRASA wastewater manhole

- e. PRASA wastewater manhole: Located at the De Diego Ave. to east of Supermax supermarket parking lot exit that is closest to the Supermax building. See Attachment I – Location Map for more details. EPA opened the manhole and found the system flowing normally at the half pipe channel, but with significant amount of solids and grease accumulation at the bottom. The manhole structure is shallow and is a recurrent overflow location during wet-weather based upon statements by DTPW personnel as well as reports received by EPA personnel. There is a storm water catch basin located near the manhole. See Attachment 2 Photos No. 32 thru No. 36.

Note: Located at the De Diego Avenue to the right of Supermax supermarket exit.

This area is considered a potential area of non-compliance that needs further investigation and collaboration between PRASA, MSJ and the DTPW to control and mitigate the unlawful discharges of pollutants into the DNER De Diego PS and subsequently into the Condado Beach Area and the Atlantic Ocean.

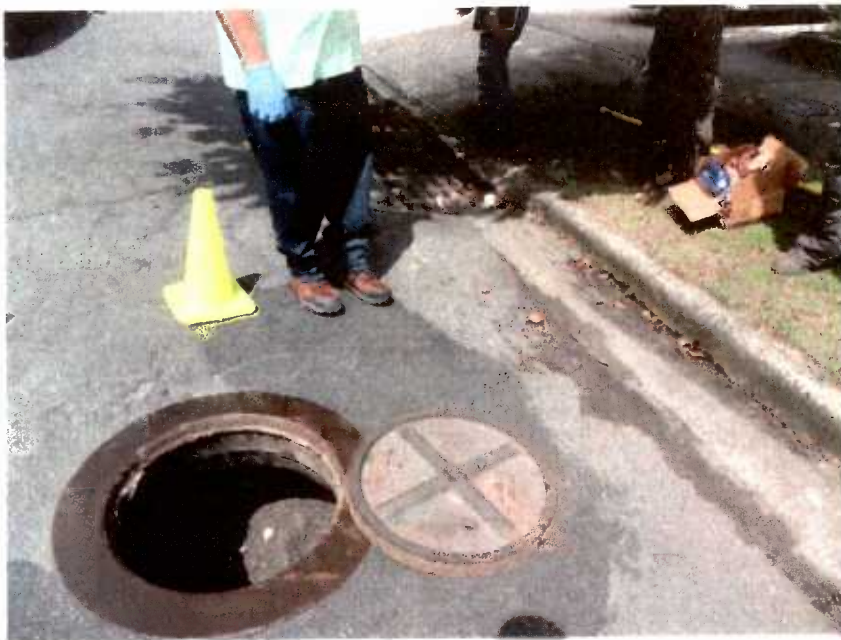
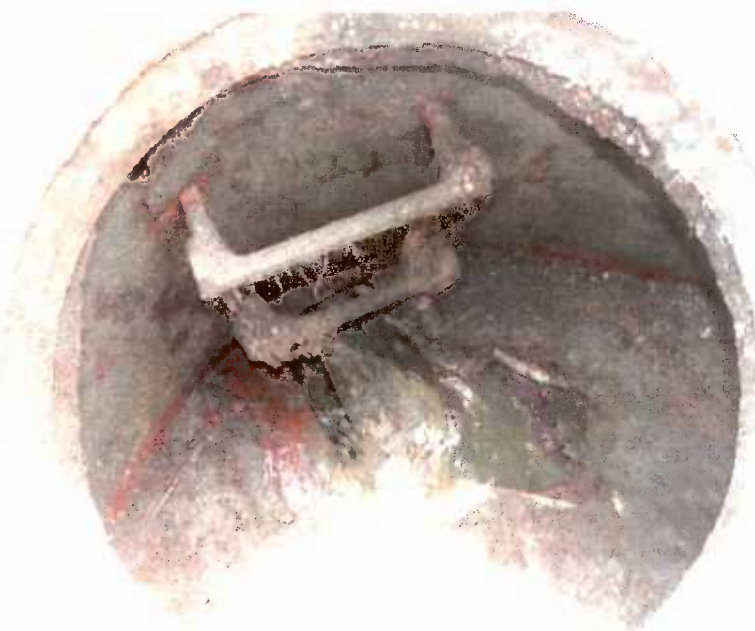
PRASA wastewater manhole

Note: EPA opened the manhole and found the system flowing normally at the half pipe channel, but with significant amount of solids and grease accumulation at the bottom.

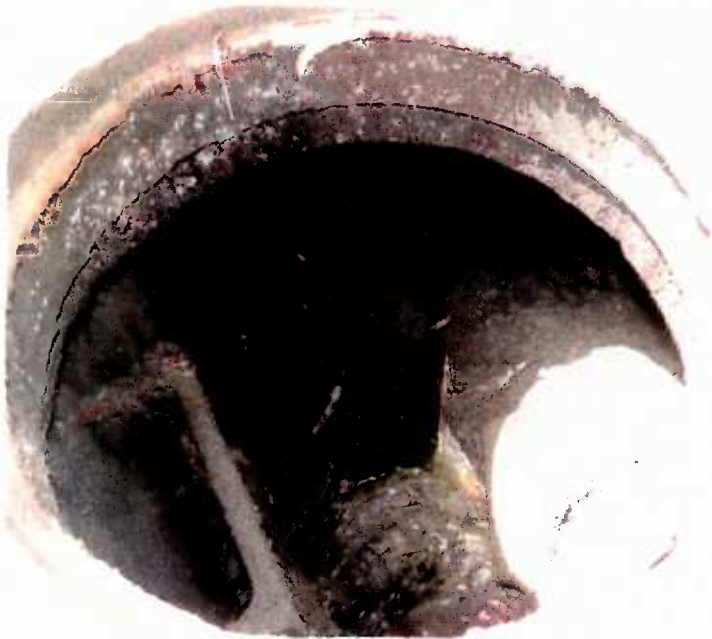
Note: EPA opened the manhole and found the system flowing normally at the half pipe channel, but with significant amount of solids and grease accumulation at the bottom.

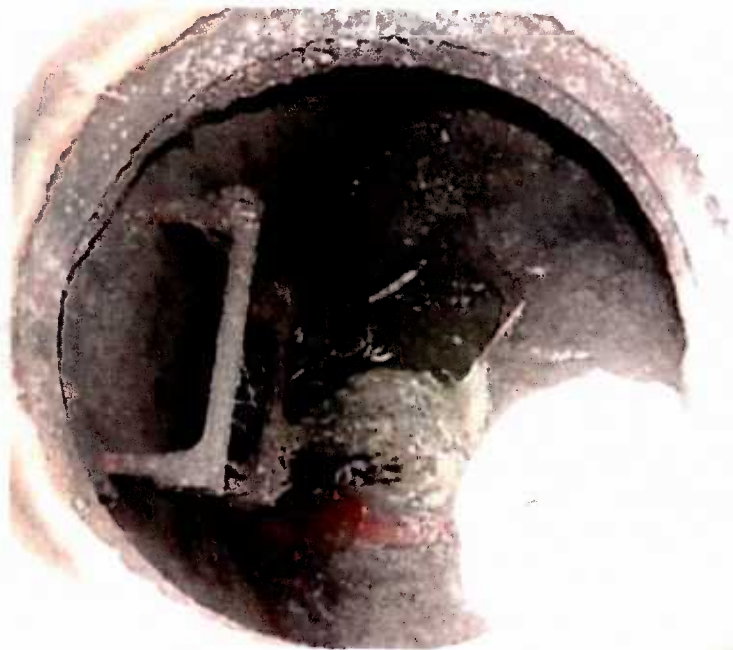
PRASA wastewater manhole

Note: EPA opened the manhole and found the system flowing normally at the half pipe channel, but with significant amount of solids and grease accumulation at the bottom.

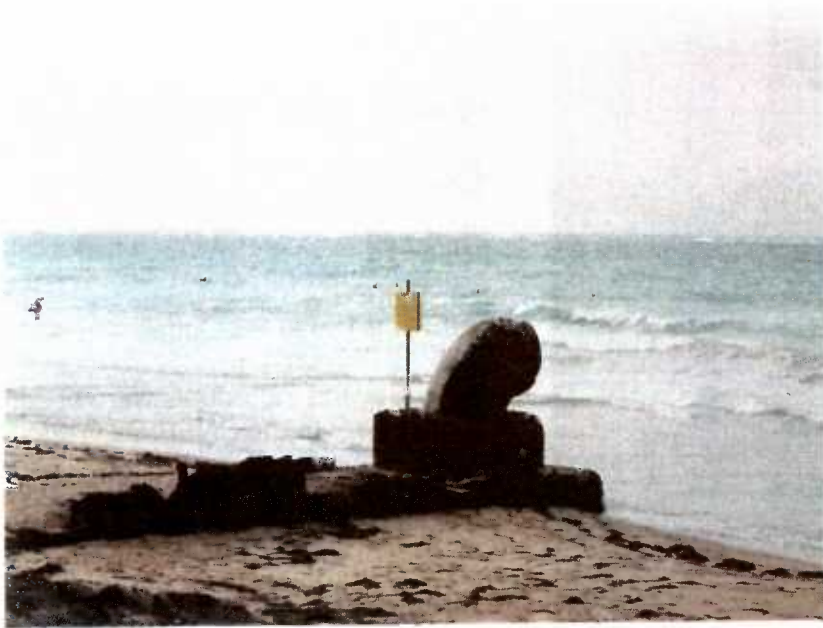
**Note:** Several individuals were observed surfing near to the DNER De Diego PS Outfall at the Condado Beach.

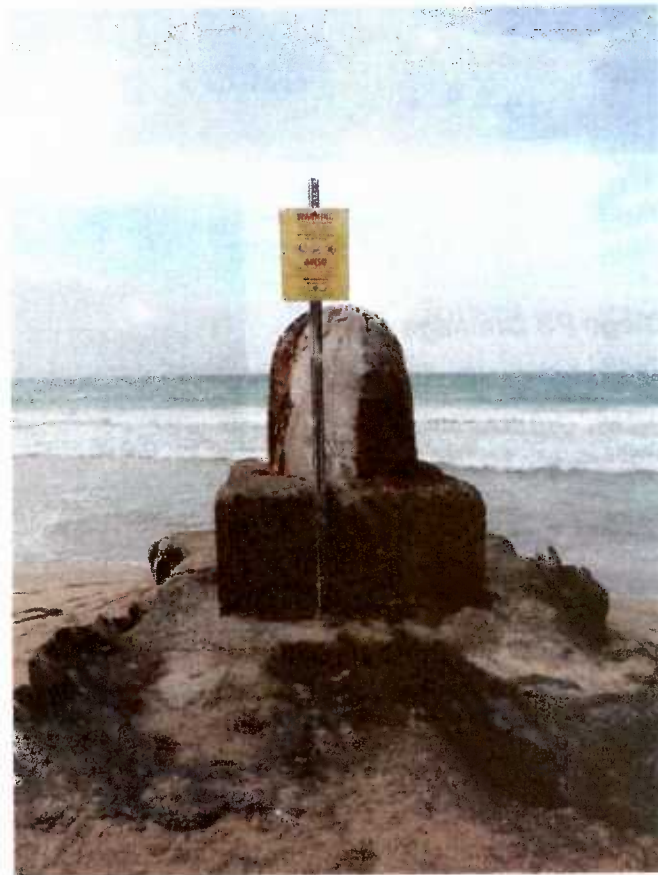
**DNER De Diego PS Outfall**

**Note:** Partial view of the DNER De Diego PS Outfall and its warning sign.
